**13 Remove Output Shaft and Upper Gearset**

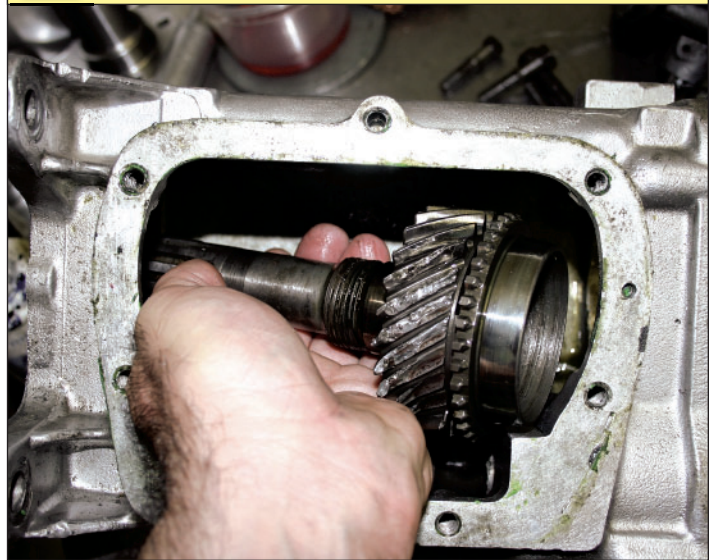
**14 Remove Input Shaft**

Pick out as many loose parts as possible, and then remove the input shaft. Broken inputs, such as this one, make great clutch-alignment tools.

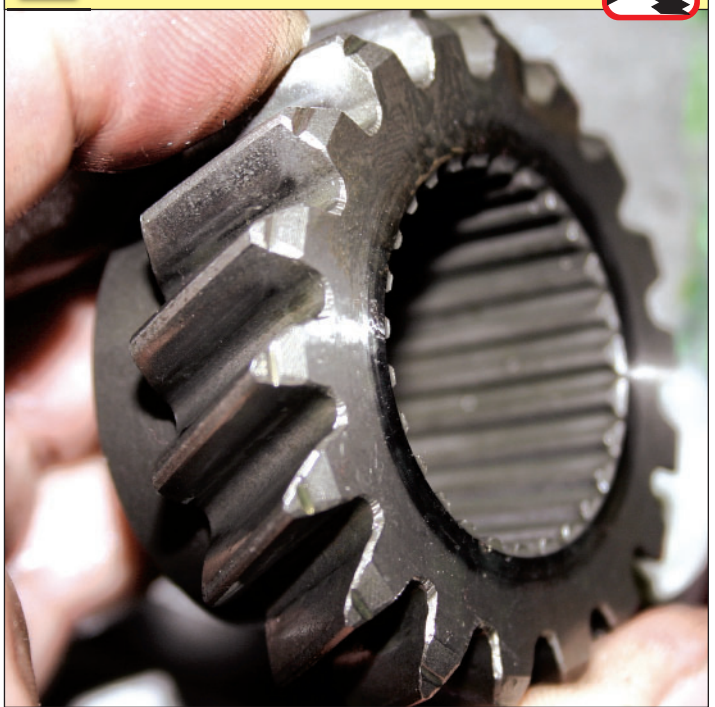
**16 Inspect Reverse Idler Gear**

**!** Inspect the forward edge of the inside reverse idler. The groove cut into the forward edge is due to the 1-2 slider hitting it. This causes a whirring noise heard only in first gear. Worn forks and slider grooves can aggravate this common design flaw.

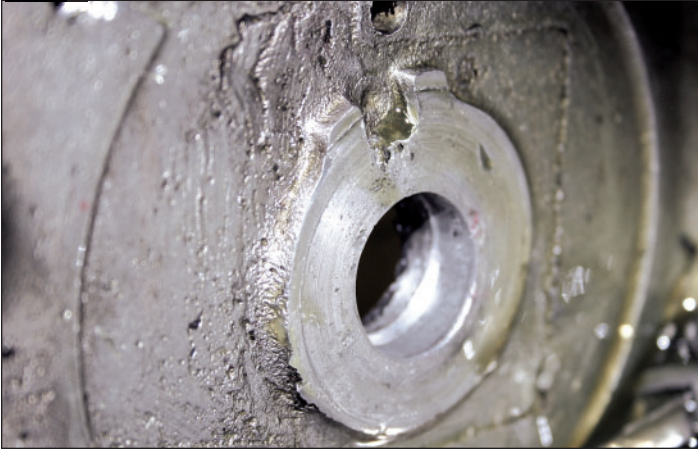
**17 Fix Countershaft Bore**

The front countershaft bore of the main case reveals a severe elongation. Boring it and installing a bushing is a common fix. This needs to be done in a machine shop on a vertical mill. Since this is a 7/8-inch-diameter countershaft, we can just bore the case to the 1-inch size and use a later-style head set. I'll scrap this case and use a new Auto Gear Supercase. If the countershaft bore is no longer a press fit and the shaft can slide in or out of the case by hand, the case needs to be repaired or replaced.

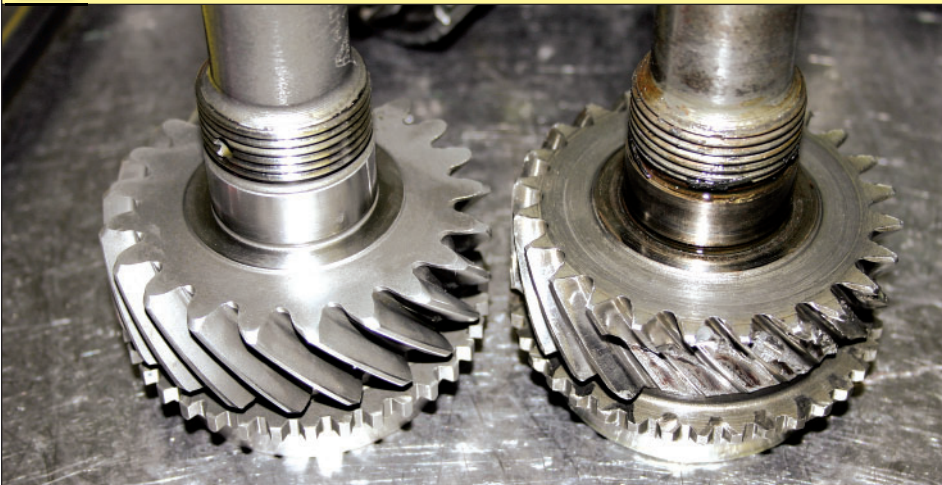
**18 Update Input Shaft**

The newer-style M20 input (left) has 21 teeth on a larger diameter, in contrast to 24 teeth on a smaller diameter (right). This makes for thicker and stronger gear teeth, and as a result, the input shaft can transmit more torque.

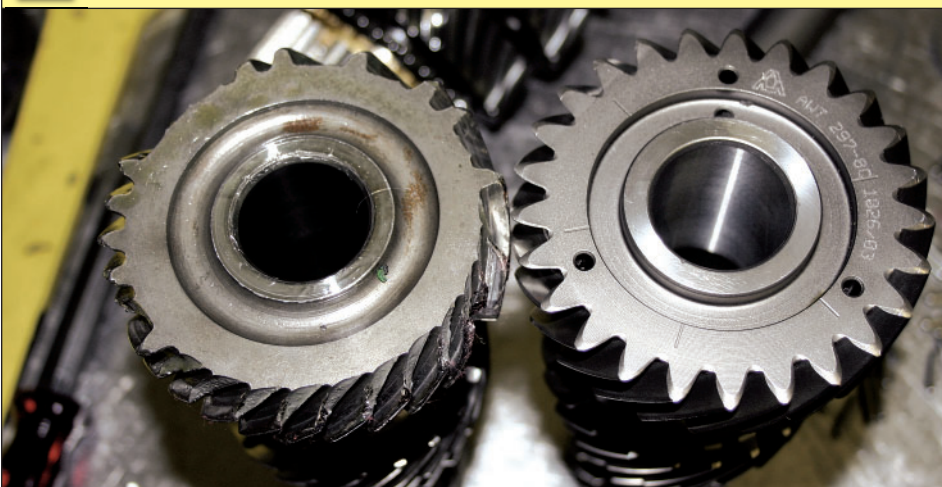
**19 Install Updated Countergear**

The M20 countergear (right) is the new design with 25 teeth, in contrast to the early 29-tooth finer pitch (left). It also takes a 1-inch countershaft. This upgrade started in 1966. The three holes in the new gear's front face are for an anti-backlash plate. Remove these plates on every M20 countergear because they have a tendency to break or loosen.
